**REMEDIAL DESIGN  
WORK PLAN TO CAP THE  
CINDER/SLAG FILL AREA LOCATED ON  
LIBERTY PROPERTY TRUST'S  
2301 RENAISSANCE BOULEVARD PROPERTY**

**Penn Environmental & Remediation, Inc.**  
2755 Bergey Road  
Hatfield, PA 19440

April 23, 2001  
4013-01000

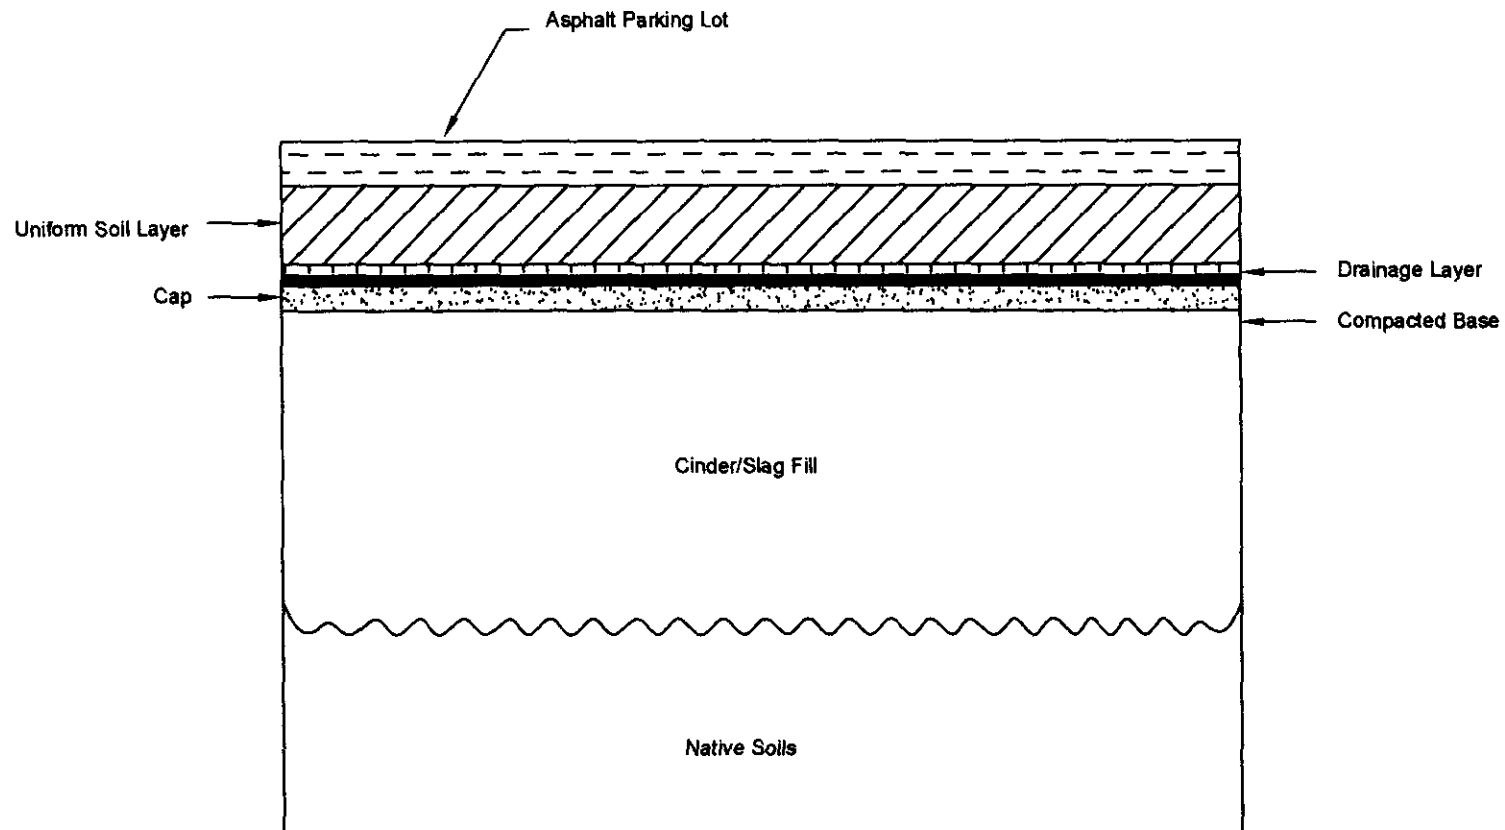
REPORT OR DOCUMENT TITLE	<u>Remedial Design (RD)</u> <u>Work Plan To Cap Fill Area</u>
DATE OF DOCUMENT	<u>April 23, 2001</u>
DESCRIPTION OF IMAGERY	<u>Figure 1- Site Layout</u> <u>Map</u>
NUMBER AND TYPE OF IMAGERY ITEM(S)	<u>1 oversized map</u>

- Figure 1: Site Layout Map for 2201/2301 Renaissance Boulevard Showing The Approximate Limits of the Cinder/Slag Fill Area
- Figure 2: Cross-Section of Proposed Cap to be Installed Over the Cinder/Slag Fill Area
